NASA Technical Memorandum 106442

# Evaluation of Oxide-Coated Iridium-Rhenium Chambers

Brian D. Reed Lewis Research Center Cleveland, Ohio

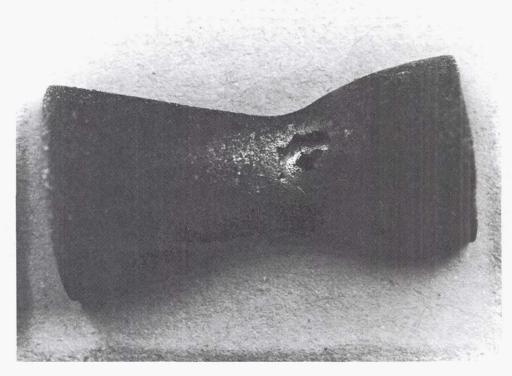
experienced by the five thick-walled chambers. The thin-walled chambers, however, suffered burn-throughs during high mixture ratio tests. For both chambers, the burn-throughs occurred in the converging section, just upstream of the throat. Figure 6 shows the burn-through for the composite chamber. It was determined that the integrity of the exterior purge was maintained during both burn-throughs, so that the burn-throughs are felt to have occurred from the inside-out. The  $ZrO_2$  chamber failed during its 7th mixture ratio 11 test, whereas the composite chamber failed during its 30th mixture ratio 16 test. For both chambers there was no evidence of imminent failure from the last visual inspection before failure. The composite chamber suffered a second burn-through in the barrel section of the chamber, close to the front end of the chamber. From videotape replay of the test, it was apparent that this second burn-through occurred after the one in the converging section.

Figure 6.—Chamber 6063-1-10 (iridium-oxide composite coating) throat region exterior.
